Woolly Beach Report

To: Shire Council

Environmental Consultant

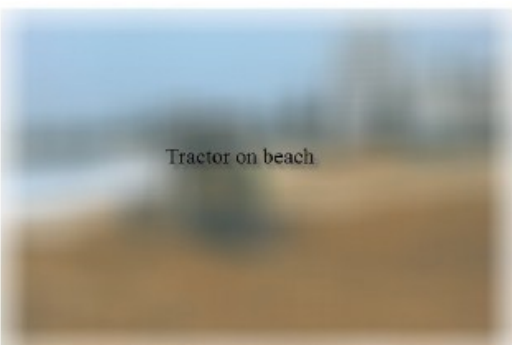
Figure 1.6- during beach nourishment.

I feel that the dunes are in quite a stable condition, yet there are areas including the bottom of the back dune and the majority of the fore dune which are definitely in need of more sand. There is evidence of longshore drift towards the left of the beach as there is a build up of sand. Beach nourishment is a handy procedure which can be taken in small steps to ensure the beach is maintained and restored to its healthy state. Although this is a very expensive resort, it will definitely be effective on XXX beach.

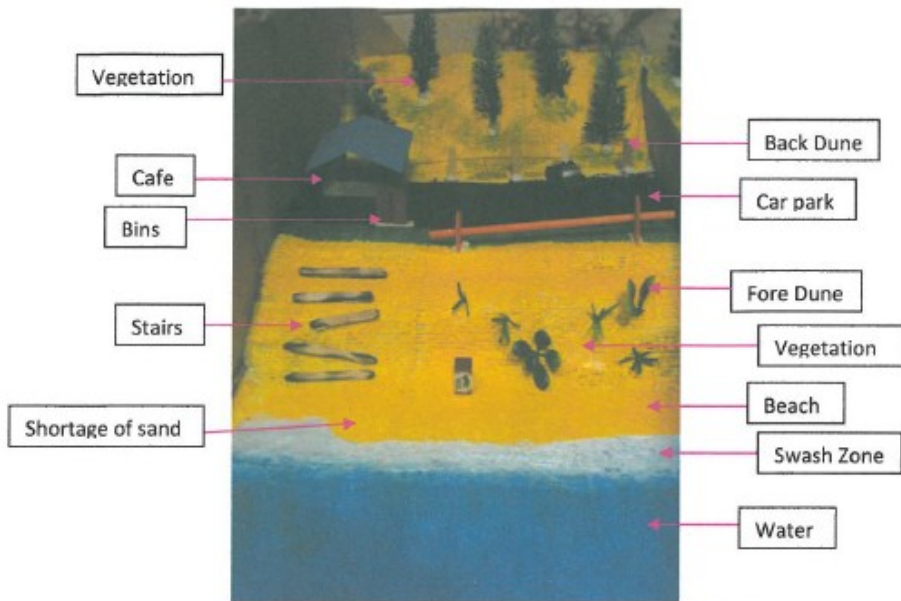
Figure 1.7-Before my inspection and reconstruction of Beach.

My diagram shows both the before and after of XXX Beach. On the before shot the dunes and beach are more eroded however, are fixed due to beach nourishment in the after. The car park on the before is dodgy not having any parking lines, where as the after has clear lines. The vegetation is much more rich in the after then the before. The bins on the before model only have junk signs and there are only two. In the after model there are three sets of bins which are clearly labelled with recycle and junk. The stairs on the before are unsafe and uneven but on the after site they are perfect. In the before, the dune fencing is almost useless and there are no signs warning intruders, however in the after shot the fences are stable and there are various signs explaining why the fences are there. The major difference is the offshore breakwater. Although this doesn't look like a big impact it stops the dramatic erosion on the beach.

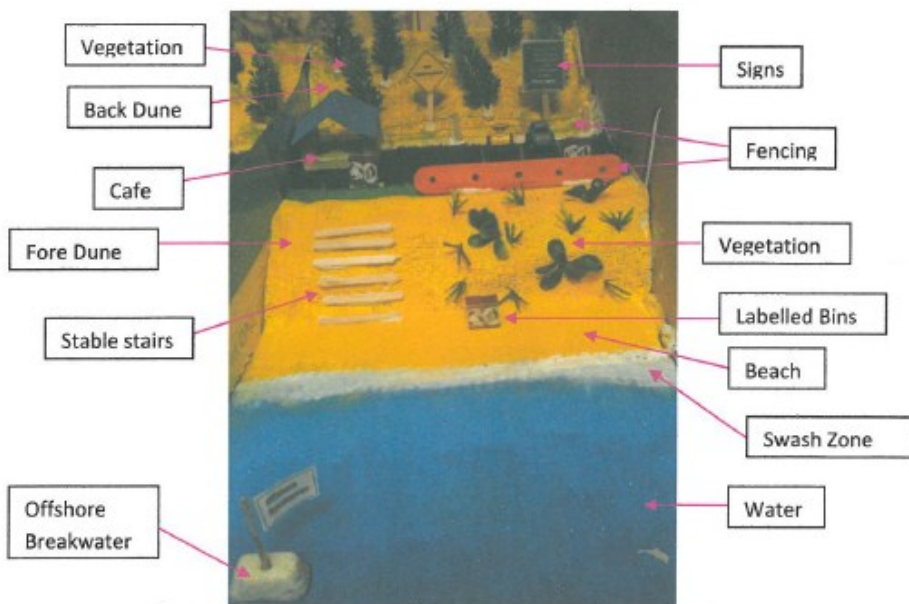
Figure 1.8-After my recommendations for Beach.
